Clinical observation of recurrent anterior dislocation of the tibial component following total knee arthroplasty

G.M. Kavalerskiy, A.V. Lychagin, S.M. Smetanin, A.A. Gritsyuk

HBEI HPO I.M. Sechenov First Moscow State Medical University, Moscow

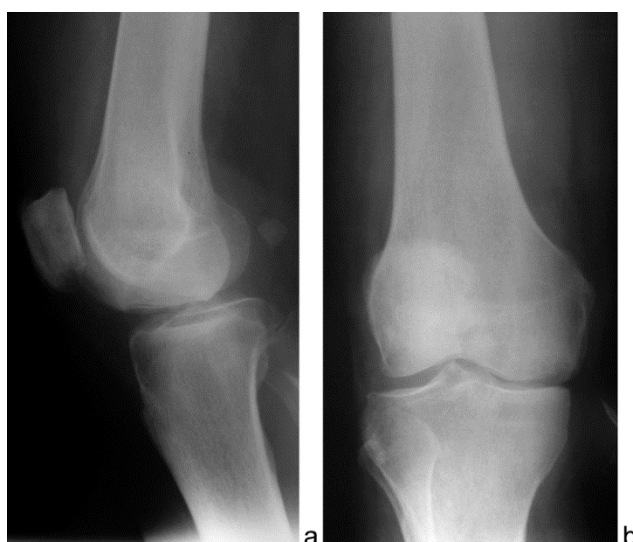
Fig. 1 Preoperative radiographs of the right knee joint of patient G.: a – lateral view, b – AP view

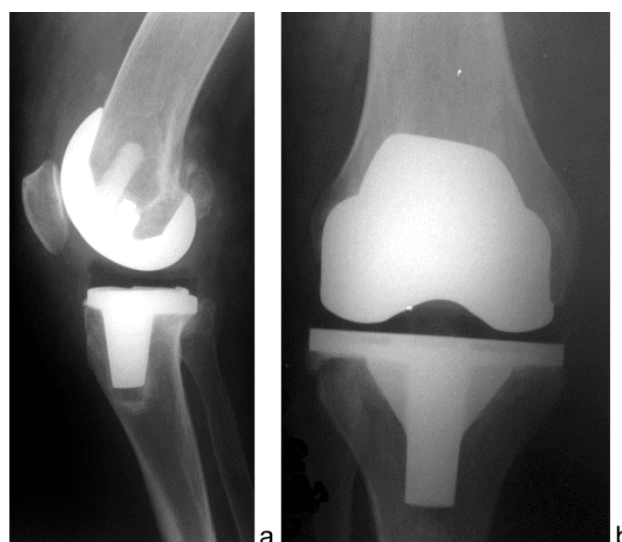
Fig. 2 Radiographs of the right knee joint of patient G. following TKA: a – lateral view, b – AP view

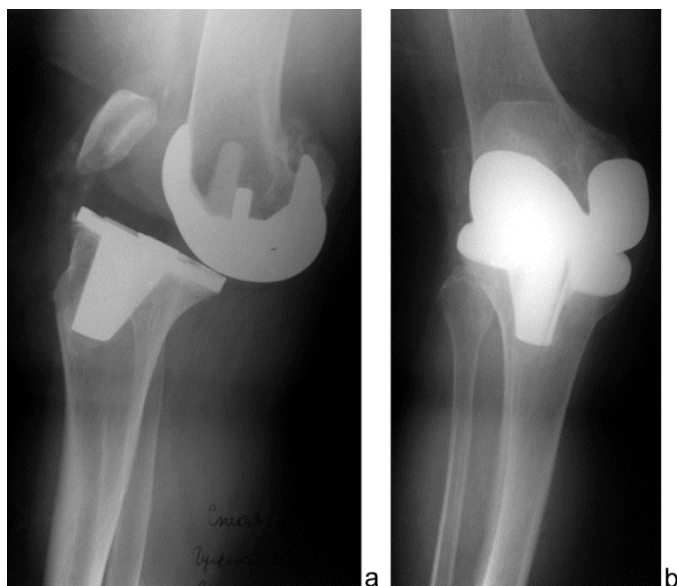
walking frame and maintained minimal weight-bearing on the leg. Her family insisted she should be examined and treated for her condition, so she was admitted to the hospital on September 28, 2015. She was unable to put weight-bearing on her right leg and developed evident pain in the knee when tried to bear weight. No vascular and neurologic disorders were observed in the right lower limb. Radiographs showed dislocated tibial component of the right knee implant (**Fig. 3**).

Fig. 3 Radiographs of the right knee of patient G. on admission: a- lateral view, b – AP view

inadequate positioning of the tibial component made during primary total knee arthroplasty on the right side. Greater tilting of the tibial component backwards as assigned by manufacturer can result in increased liner wear and decreased survival of the tibial component. Femoral component could slip off backwards with occasional injury.

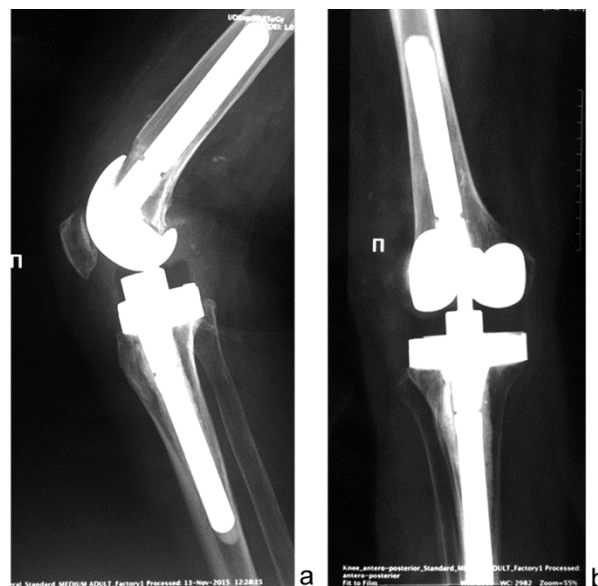
Fig. 4 Radiographs of the right knee of patient G. after revision TKA: a – lateral view, b – AP view

Revision TKA using LCCK was performed on October 14, 2015 following the removal of all the components (**Fig. 4**). No instability of implant components and liner wear were observed intraoperatively.

Revision surgery in this case involved a lot of tibial bone resection for posterior levelling of the inclination angle. The usage of a constrained condylar knee component with the possibility of applying augments for the tibial component is essential for a good functional result of treatment.

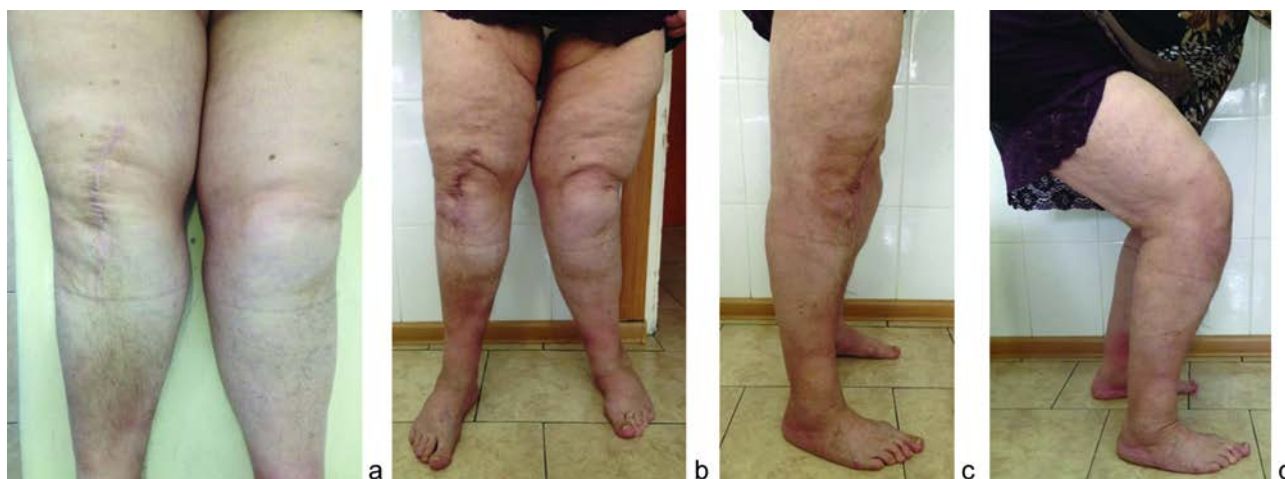
A six-month follow-up showed her walking with full weight-bearing on the operated limb using no crutches and having no pain. Clinically she demonstrated well aligned limb with a range of motion in the knee joint being 0/0/100 (**Fig. 5**). Radiographs of the right knee joint showed correct components' placement with no signs of instability (**Fig. 6**).

Fig. 5 Photographs of lower limbs of patient G at six-month follow-up: a – postoperative scar; b – front view; c – lateral view; d – flexion of the right knee joint

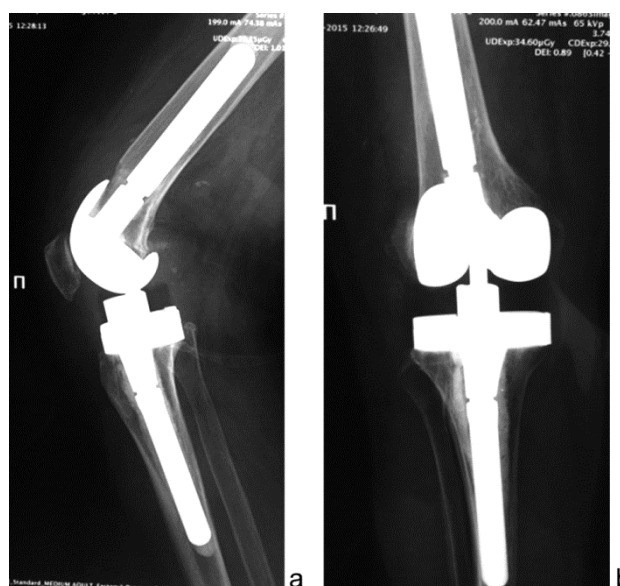
Fig. 6 Radiographs of the right knee joint of patient G. six months following revision TKA: a – lateral view; b – AP view
